**SILVER STREAKS ON SURFACE
OF INJECTED THERMOPLASTIC PARTS**

Jozef BÍLIK, Antonín NÁPLAVA,
Martin KUSÝ, Miroslav KOŠÍK, Lukáš LIKAVČAN

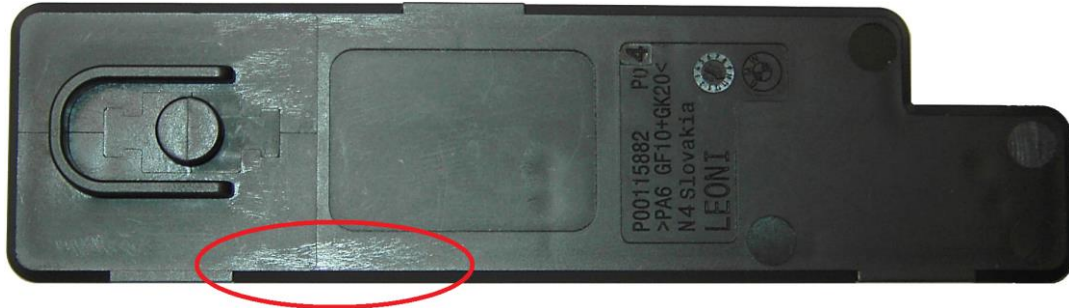
The silver streaks were observed on the surface of a thermoplastic cover (Figure 1), made of PA6 polyamide with 20 % glass beads and 10 % glass fibres in weight ratio. In the Figure, the defect is marked by a red ellipse.

Fig. 1 A plastic cover (reject) with silver marks

Streaks looked like a cluster of reinforcing fibres on the part surface in thick-walled areas and the areas around the cavity gate. The defect looked like a narrowed short silver lines, oriented in downstream of the plastic melt. To verify the assumption that streaks are not consequence of fibres clustering on the part surface, the specific areas were scanned with Zeiss Axio imager 2 microscope in both polarised and non-polarised lights in various magnifications. The following figures compare the part surfaces of the clean area without silver lines (Fig. 2) and the reject area with silver lines (Fig. 3) in non-polarised light.

- increasing the gate size (to decrease shear rates),
- increasing the melting temperature,
- increasing the cavity filling time,
- increasing the melt homogenisation time,
- increasing the mould temperature.

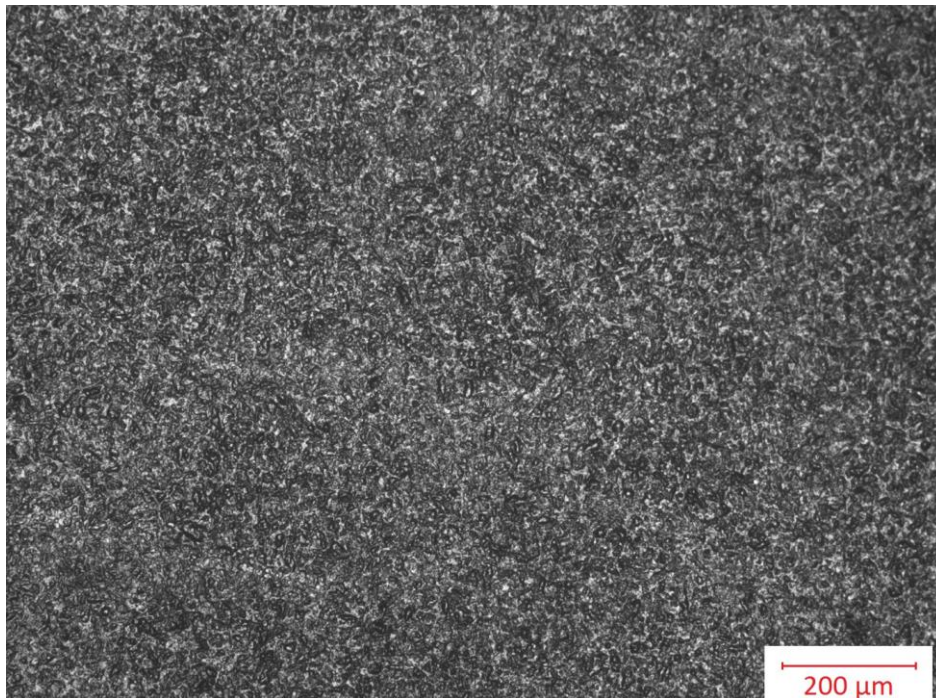
Fig. 2 Part surface of the area without silver marks

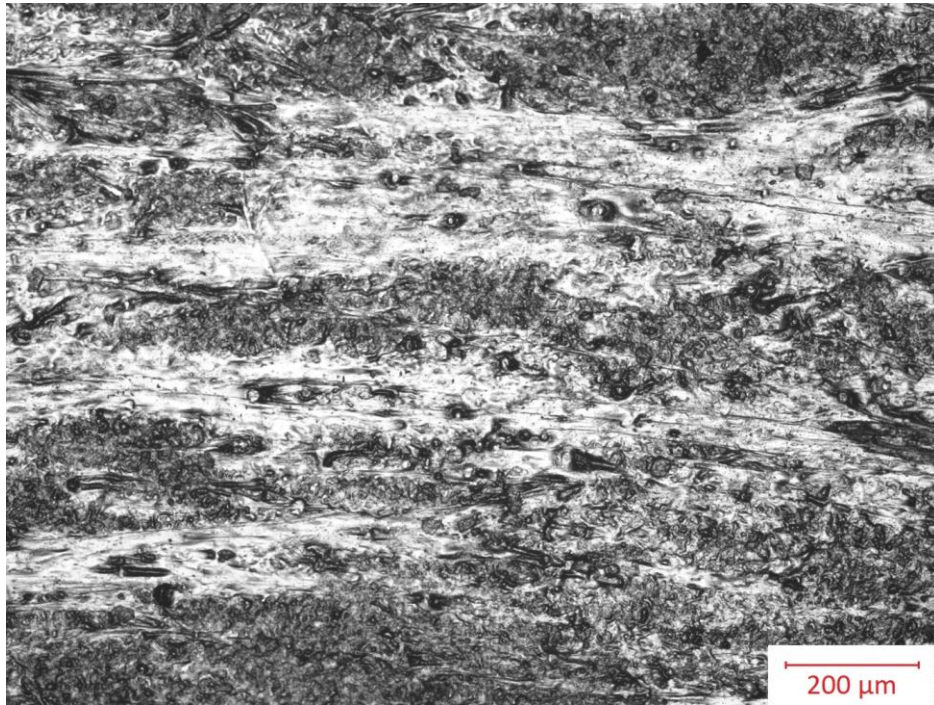
Fig. 3 Part surface of the area with silver marks

As shown in Figure 3, although glass fibres and beads were visible on the surface, it was not their clustering. The observed sort of marks on the reject areas is typical for moisture, air bubbles or depredated particles in the polymer melt.

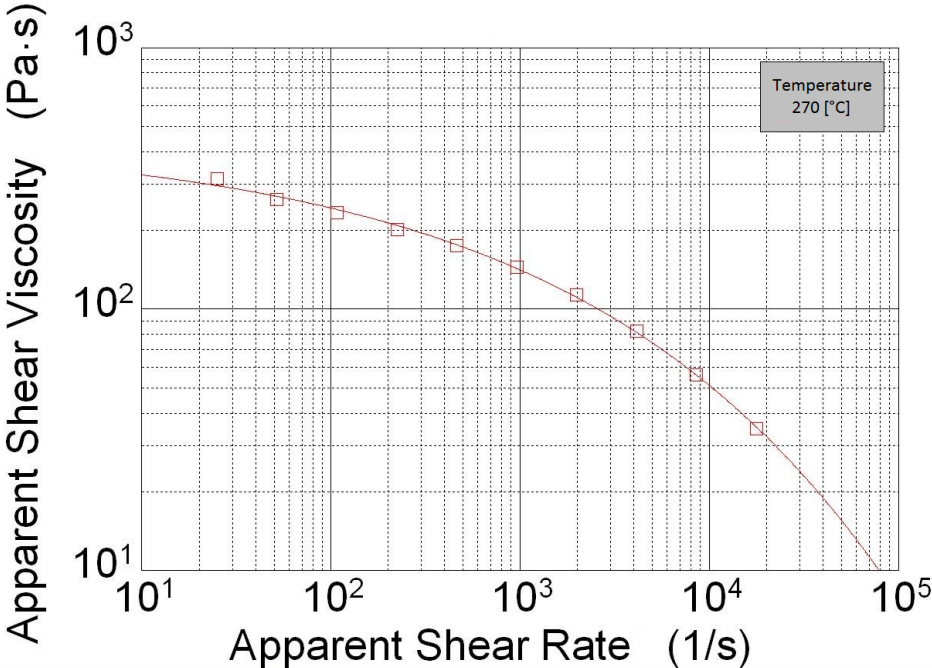
As observed during viscosity measurement, the set melting temperature appeared to be low. As the graph in Figure 4 shows, the measured melt viscosity was not too high, but the increase of melting temperature could help gases better escape from the melt, and also reduce the melt homogenisation time. To verify suitability of the melting temperature increase, CAE analysis was additionally done.

Fig. 4 Measured shear viscosity vs. shear rate functionality

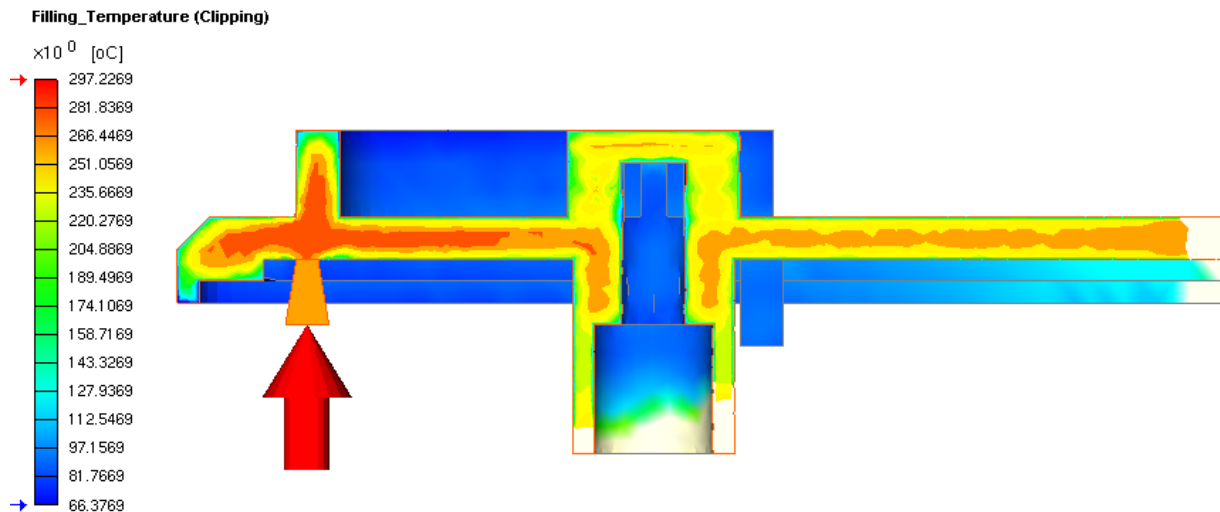
At first, FVM CAE analysis with the real production conditions was conducted in Moldex3D Solid. The melt was injected by the hot runner system with temperature 270 °C and the gate of about 1mm diameter in size. As the results of cavity filling showed, during injection process, the high shear rates were generated in the cavity gate. In general, the

maximum recommended shear rates for polyamide 6 are $60\,000\text{ s}^{-1}$. However, the shear rates generated during injection achieved $130\,000\text{ s}^{-1}$ according to Moldex3D results. As a consequence of the high shear rates generation, temperature of melt increased to the value above $295\text{ }^{\circ}\text{C}$. In Figure 5, temperature fields in the cross section of cavity are plotted in time 0.5 second of filling. The red arrow indicates location of gate of the hot runner system. The melt temperature increase explains, why initially apparent low melt temperature was finally sufficient during injection

Fig. 5 Temperature fields in cross section of cavity during injection

As the results of the simulation show, high shear rates generated in melt during injection significantly increased the melting core temperature. Since additional preheating of the melt can generate more gases in the cavity, the increase of the initial melt temperature was not recommended. As a solution to the silver marks elimination, the following procedures were suggested:
