HYDROGEN EMBRITTLEMENT IN HEAT AFFECTED ZONE OF A WELDED SHEET OF PRECIPITATION HARDENING MARTENSITIC STAINLESS STEEL

INTRODUCTION

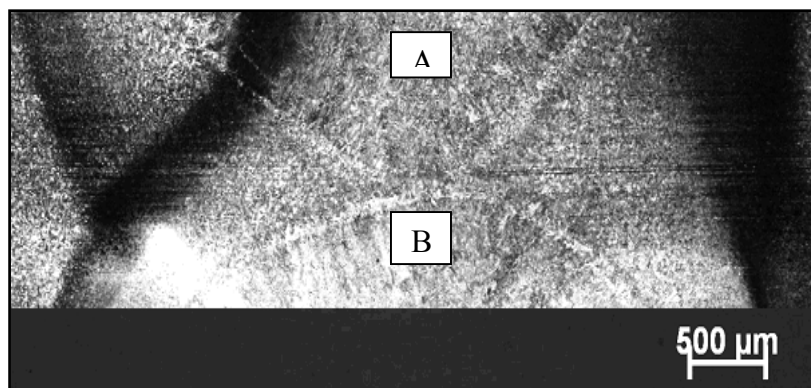
Figure 1 Macrograph of the cross-section of welded region / Dark tinted region is visible on both sides of weld seam/ A is 1st weld pass seam; B is 2nd weld pass seam. Etchant: W II (Wallner)

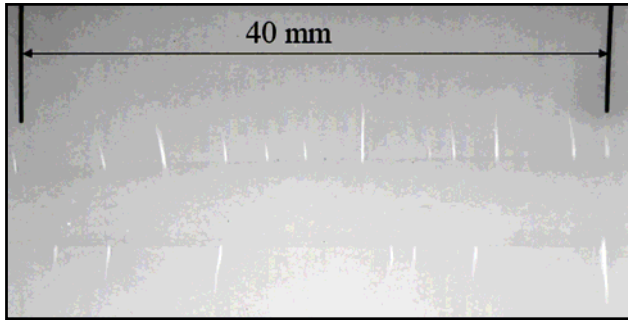
Figure 2 X-ray micro radiography image of the welded sheet, cracks are visible on the both sides perpendicular to weld-seam (white)

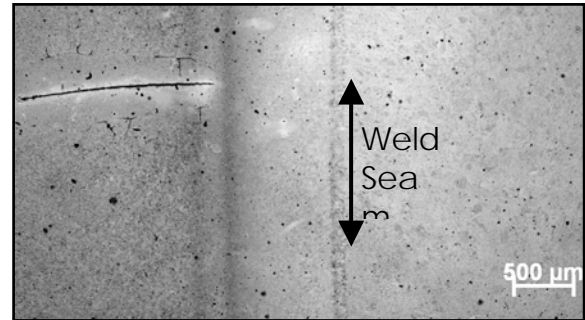
Figure 3 Macrograph of one of the cracks/ viewed from LT direction/ Etchant: W II (Wallner)

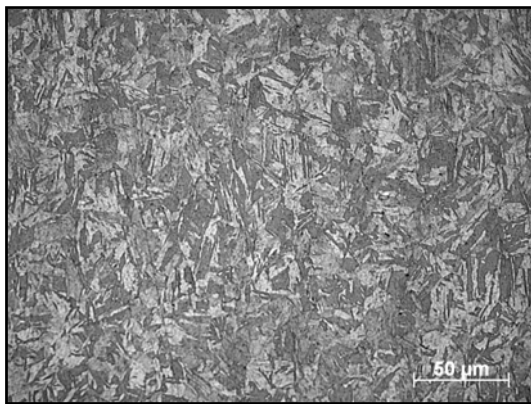
Figure 4 Base metal with typical martensitic microstructure. No delta ferrite is visible in this micrograph (LT plane) etched with Beraha I

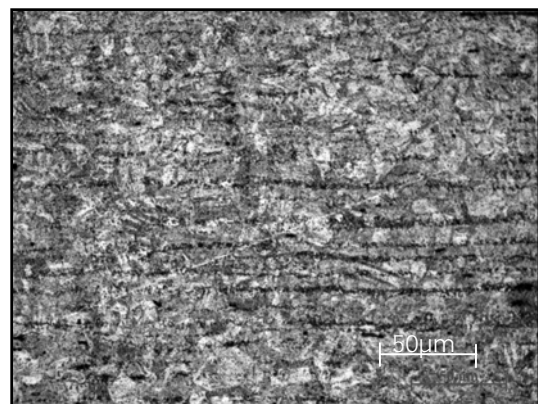
Figure 5 Base metal etched with W II (Wallner), segregation lines are visible (ST Plane)

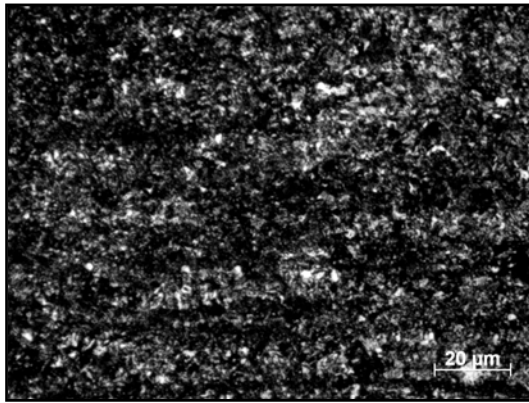
Figure 8 Microstructure of black tinted region in the HAZ (ST Plane)

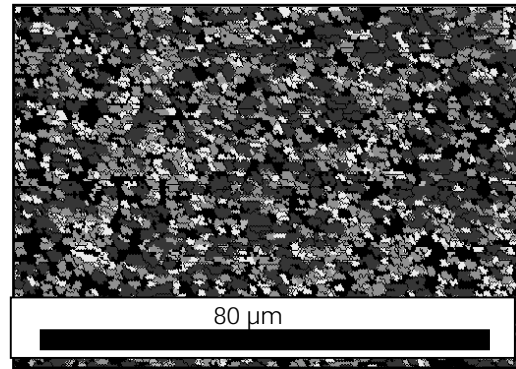
Figure 9 Grain size mapping of region in Figure 8, by EBSD. (ST Plane). Gray scale indicates the size class

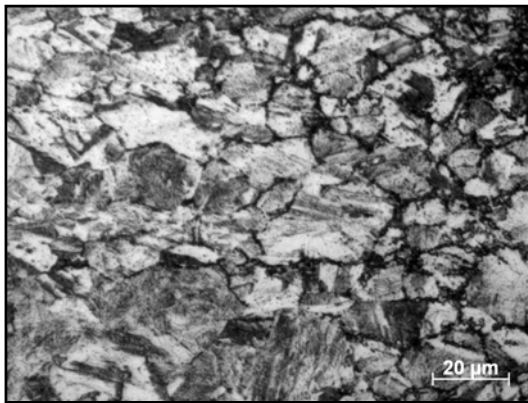
Figure 10 Microstructure region in the HAZ adjacent to Fig. 8, (ST Plane)

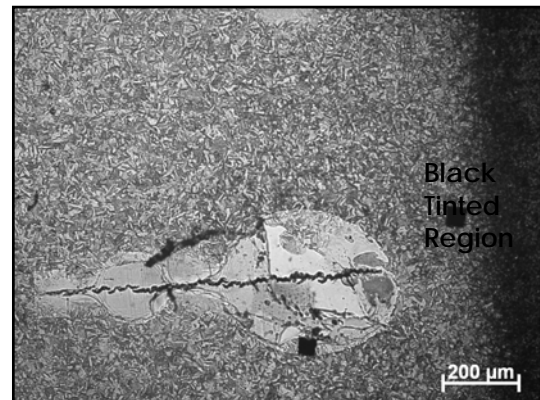
Figure 11 Macrograph of crack, in the region shown in Figure 10. (LT Plane)

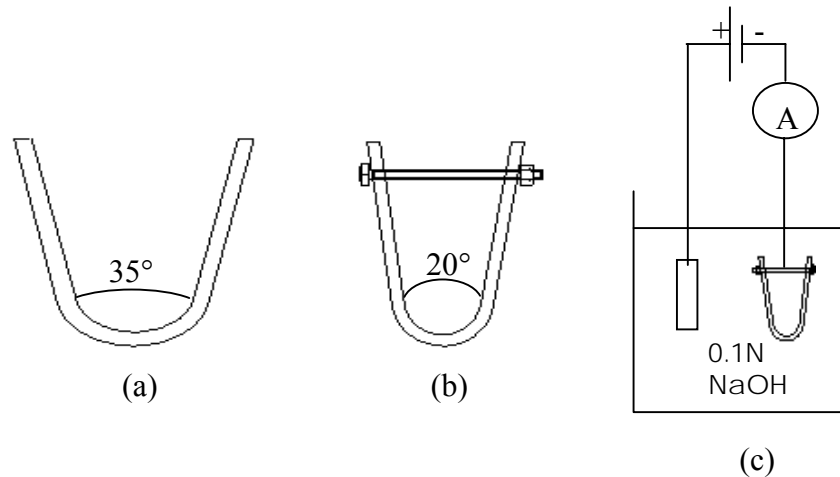
Figure 12 Sketch of U shaped specimen used for hydrogen loading, a) Before screwing, b) After screwing to maintain tensile stress on the outer side of the bend, c) Schematic presentation of experimental setup

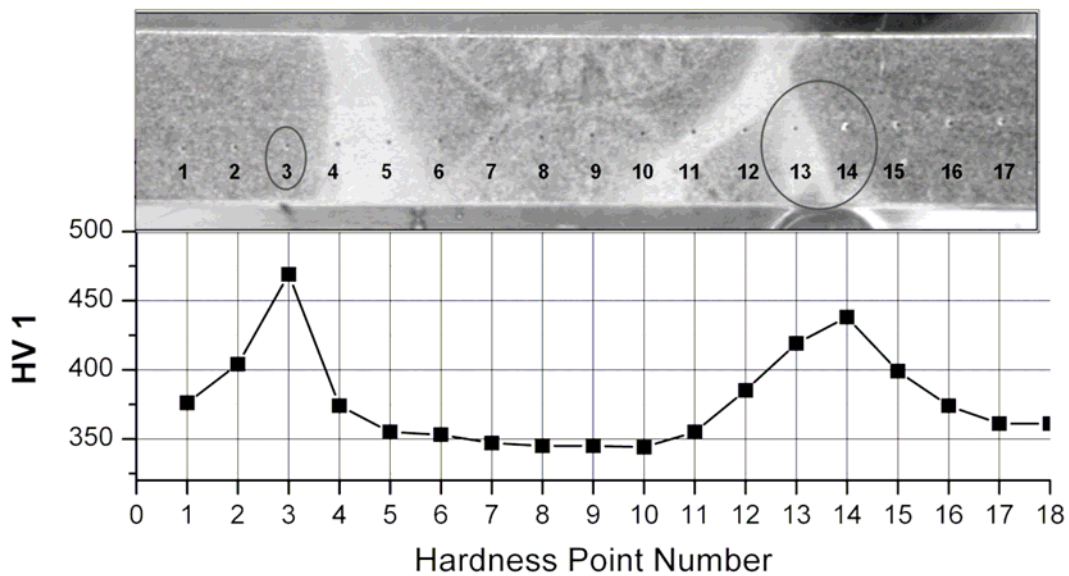
Figure 13 Micro hardness measurements along cross-section of the weld and the HAZ

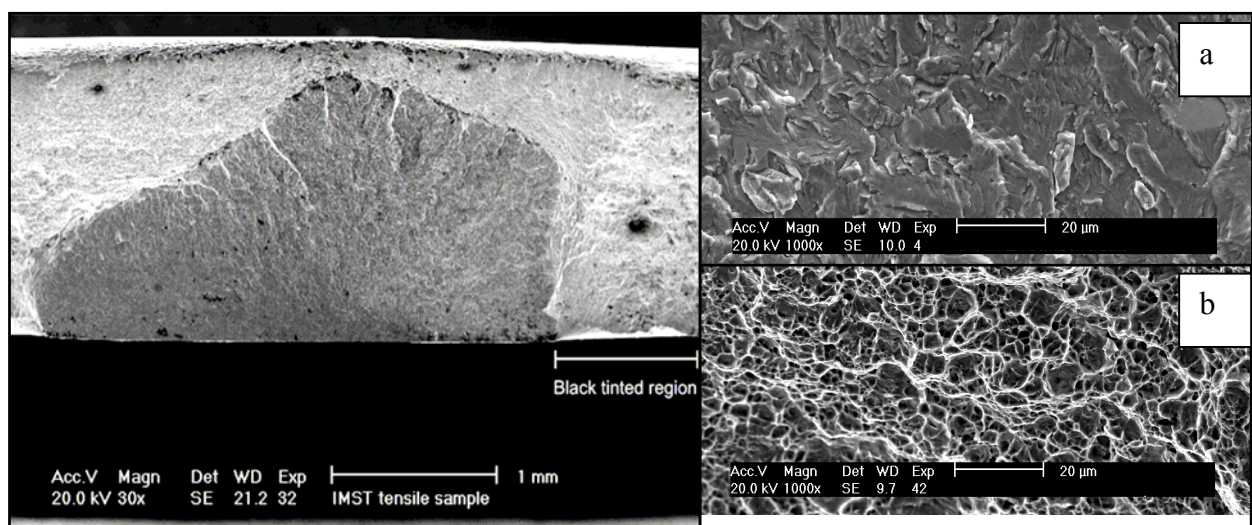
Figure 14 Crack fractography, white crack propagation lines pointing towards crack initiation, a): Cracked surface showing brittle fracture which has propagated trans-granularly characterizing hydrogen embrittlement b) Portion of the enforced fracture surface of a typical ductile fracture mode

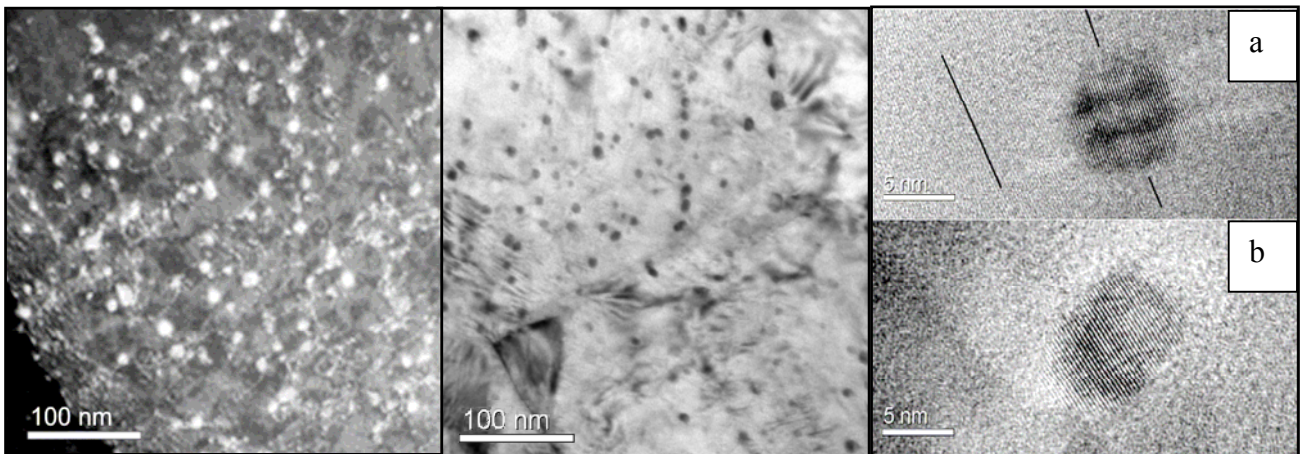
Figure 15 TEM dark field image, showing high density of precipitation in the black tinted region

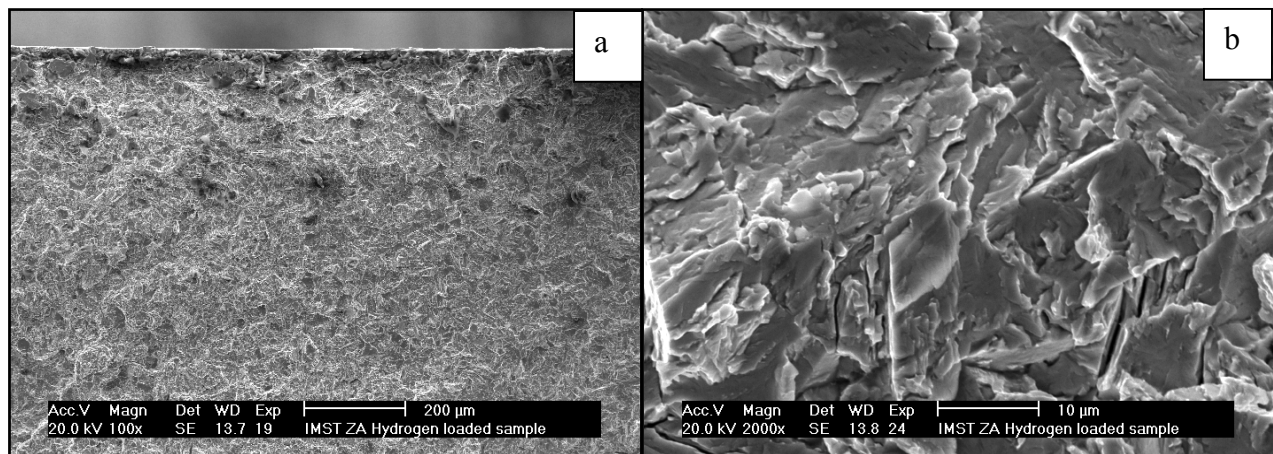
Figure 18 a) Crack Fractography, crack was produced during hydrogen loading experiment. b) At higher magnification the crack tip is found to propagate transgranularly in a brittle fashion
