# VPLYV MAZIVA NA ŽIVOTNOSŤ PRETLAČOVACIEHO NÁSTROJA PRE TVÁRNIENIE ZA TEPLA PRI VÝROBE BEZŠVOVÝCH RÚR

## LUBRICANT INFLUENCE ON THE EXTRUDING PUNCH LIFE FOR HOT FORMING PROCESS OF SEAMLESS TUBES PRODUCTION

Martin RIDZOŇ, Jozef BÍLIK

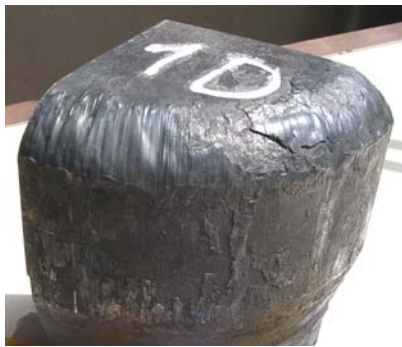
a)

The surface defects of the extruding punch head are shown in picture n<sup>o</sup>. 2a. The whole surface of the extruding punch head n<sup>o</sup>. 1 is covered by a scale layer (of varying thickness) which is stuck on the surface. Locally, this scale layer is partially scaled off. The scale layer, which is stuck within the field R20, is partially scaled off. The scabs are a potential source of particles that might get loose during the extrusion and create scratches. By means of light microscopy, some scale layers and adhesive scabs were identified on the active surface of the extruding punch head. Within the fields with the scabs, the tool surface was badly deformed (see picture n<sup>o</sup>. 3a).

Continuous application of lubricant Phosphaterm 901 in the system “extruded block – extruding punch head” resulted in creation of sporadic scabs. Within the fields with the scabs, the surface of the tool was badly deformed.

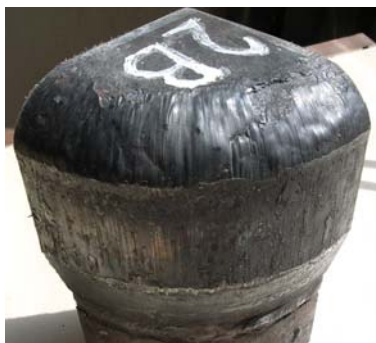
b)

The surface defects of the extruding punch head are shown in picture n<sup>o</sup>. 2b. The whole surface of the extruding punch head is covered by a scale layer (of varying thickness) which is stuck on the surface. This scale layer is partially and incompletely scaled off. The radius field R20 is covered by a nearly continuous and compact scale layer. By means of light microscopy, some scale layers and a nearly continuous interlayer were identified on the active surface of the extruding punch head (see picture n<sup>o</sup>. 3b). No scabs are created on the surface of the extruding punch head from the material of the block. Plastic deformation of the surface of the extruding punch head is insignificant.

Continuous application of lubricant Phosphaterm 3999 in the system “extruded block – extruding punch head” didn’t result in creation of the scabs (made of the block material) on the surface of the extruding punch head. The plastic deformation of the surface of the extruding punch head is insignificant.

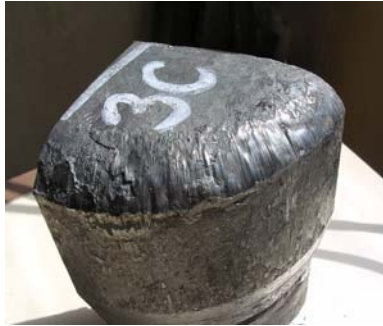
c)

The surface defects of the extruding punch head are shown in picture n<sup>o</sup>. 2c. The surface of the extruding punch head is covered by a scale layer (of varying thickness) which is stuck on the surface. The scale layer is partially scaled off. The R20 field surface of the extruding punch head is partially worn. An observable scale layer is stuck on the surface of the transitional area between cylindrical part of the punch head and the area of R20 radius. The scale layer creates a little broken projections of various lengths. There is a visible change of geometry within the area of R20 radius. The scale layer stuck within the area R20 is massive, partially scaled off and it is a potential source of particles that might get loose while the block is extruded. By means of light microscopy, some scale layers and adhesive scabs were identified on the active surface of the extruding punch head. The scale is pressed in to the surface layers, the plastic deformation occurs (see picture n<sup>o</sup>. 3c).

**Picture n°.2** The extruding punch head, close-up of the face, R20 radius and side surface of the punch head

Continuous application of lubricant Phosphaterm 901 in the system extruded block – extruding punch head resulted in degradation of the face surface, R20 radius and the cylindrical part of the punch head, similar to that which could be seen on the extruding punch head that had been lubricated by graphite.

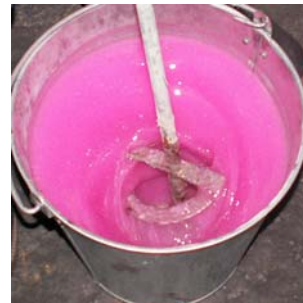
**Picture n°.5** Phosphatherm 3999, fluid state

The analysis results in the statement that Phosphatherm 3999 is the most suitable lubricant. The application of the correct lubricant Phosphatherm 3999 (see pictures n°. 4 and 5) will abolish the high dust nuisance that is caused by the powdered graphite flying up when using a standard lubrication, thereby improving the work place quality. Moreover, the choice and application of the correct lubricant influences the reduction of the punch head wear and degradation, as well as reduction of number of scratches on the inner surface of the pressed piece.
