NEW INVESTIGATIONS AND APPROACHES TO EXPLAIN STANDSTILL MARKS ON ROLLER BEARINGS (FALSE BRINELLING)

Markus GREBE

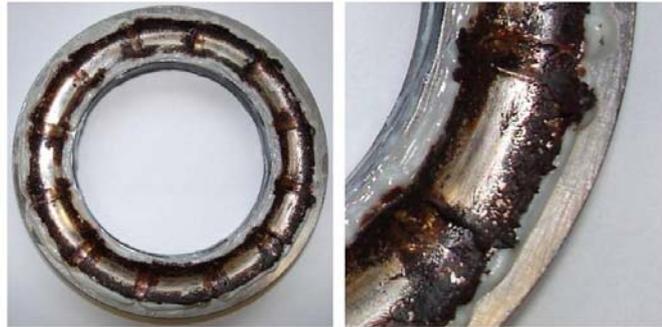
Fig. 1 Axial ball bearing with advanced damage

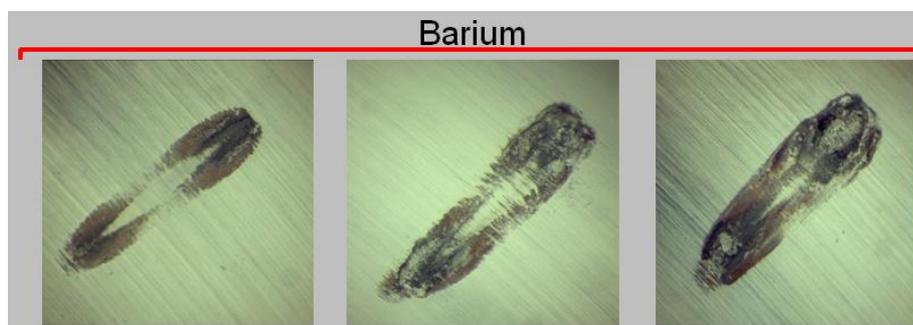
Fig. 7 Marks after 1 min., 6 min. and 80 min. with a barium soap grease

The mentioned damage mechanisms described above cause the production of wear particles and reaction products, which are not pushed out of the friction area due to a lack of “real” relative movement and thus have a strong abrasive effect. This phenomenon correlates with the formation of fretting corrosion (tribo-chemical corrosion) and normally leads to the damage progression and deep indentations which cover the traces of the original damage mechanism. In further damage progression and bearing rotation, there are additional wear mechanisms (in particular abrasion and surface disruption), which overlap and add to the covering of the real cause of damage. Depending on the predominance of one or several of the mechanisms described above, there are different types of standstill marks. The predominance of one mechanism depends on the load conditions – and within those mainly from the oscillation angle. Another damage factor with strong influence is the lubricant used. Unfortunately, main parts of this project part were sponsored by lubricant industry and are accordingly confidential. An exemplary result of unsuitable barium grease is shown in Figure 7.
